DEPARTMENT OF TRANSPORTATION**DIVISION OF ENGINEERING SERVICES**

Quality Assurance and Source Inspection

Contract #: 04-0120F4Cty: SF/ALA Rte: 80 PM: 13.2/13.9File #: 69.28**WELDING INSPECTION REPORT****Resident Engineer:**Pursell, Gary**Address:** 333 Burma Road**City:** Oakland, CA 94607**Report No:** WIR-002643**Date Inspected:** 10-May-2008**Project Name:** SAS Superstructure**OSM Arrival Time:** 630**Prime Contractor:** American Bridge/Fluor Enterprises, a JV**OSM Departure Time:** 1530**Contractor:** Zhenhua Port Machinery Company, Ltd (ZPMC), Changxing Island **Location:** Shanghai, China**CWI Name:** Chen Chih Ming**CWI Present:** Yes No**Inspected CWI report:** Yes No N/A**Rod Oven in Use:** Yes No N/A**Electrode to specification:** Yes No N/A**Weld Procedures Followed:** Yes No N/A**Qualified Welders:** Yes No N/A**Verified Joint Fit-up:** Yes No N/A**Approved Drawings:** Yes No N/A**Approved WPS:** Yes No N/A**Delayed / Cancelled:** Yes No N/A**Bridge No:** 34-0006**Component:** OBG**Summary of Items Observed:**

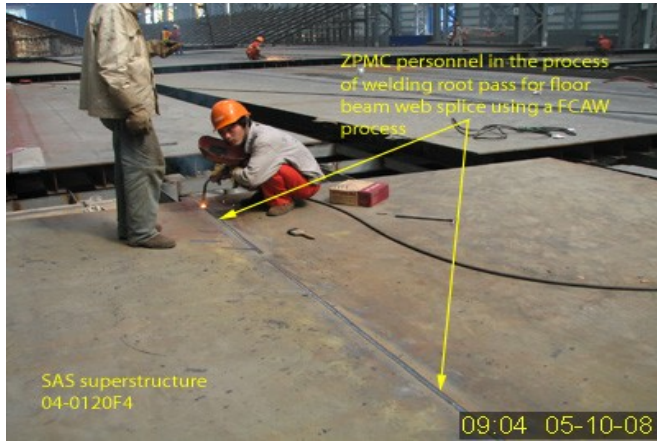
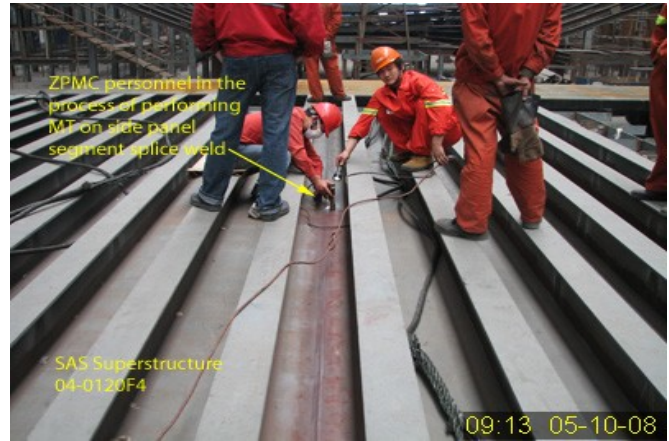
The following digital photograph below illustrates observation of the activities being performed.
